STRUCTURAL INTEGRITY INVESTIGATIONS

Administration block located on Plot _____, Amuria District Local
Government Headquarters

Project No. 0071/AMRT/NOV-INT/2018

NOVEMBER, 2018

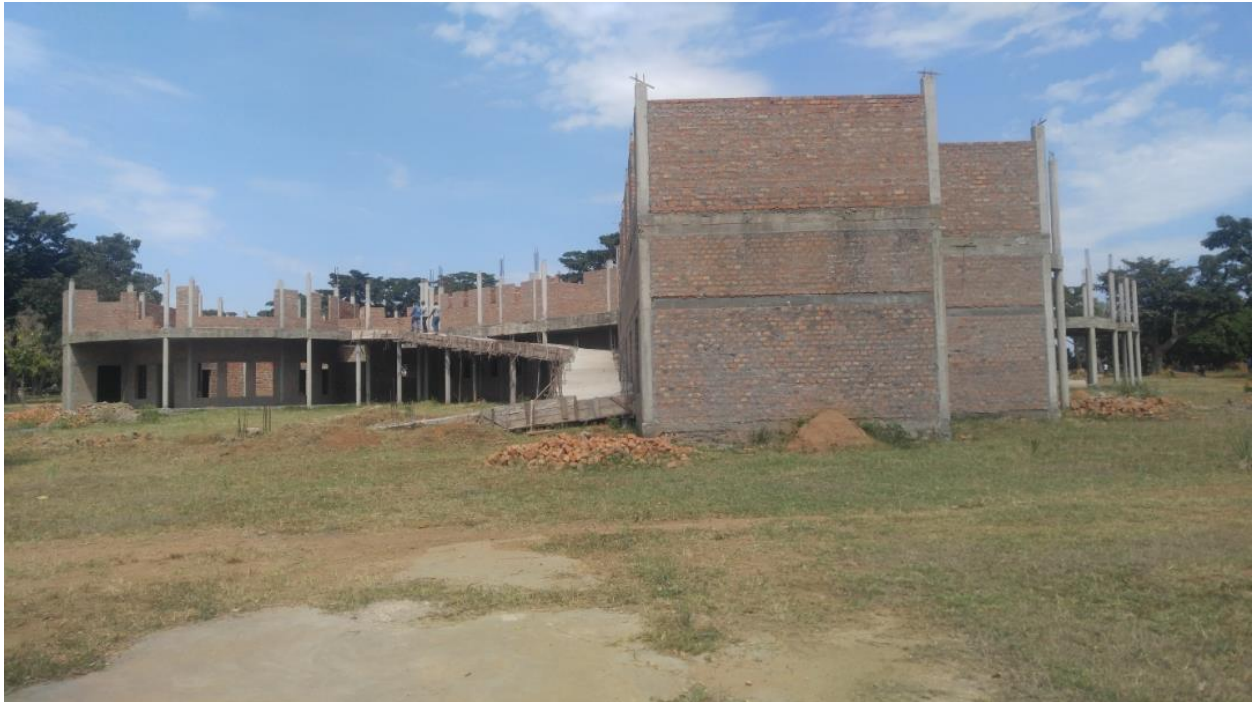
Photo plate 01: the as built structure under investigation.

The building under investigation is an incomplete single storied administrative building at the time of investigation. The structure is a framed reinforced concrete structure having reinforced concrete beams, columns, stair cases, footings and max span suspended slab. The walling infill material was found to be of common burnt clay bricks bonded in cement sand mortar of unknown ration/mix. The existing structure was as seen in the photo plate below.

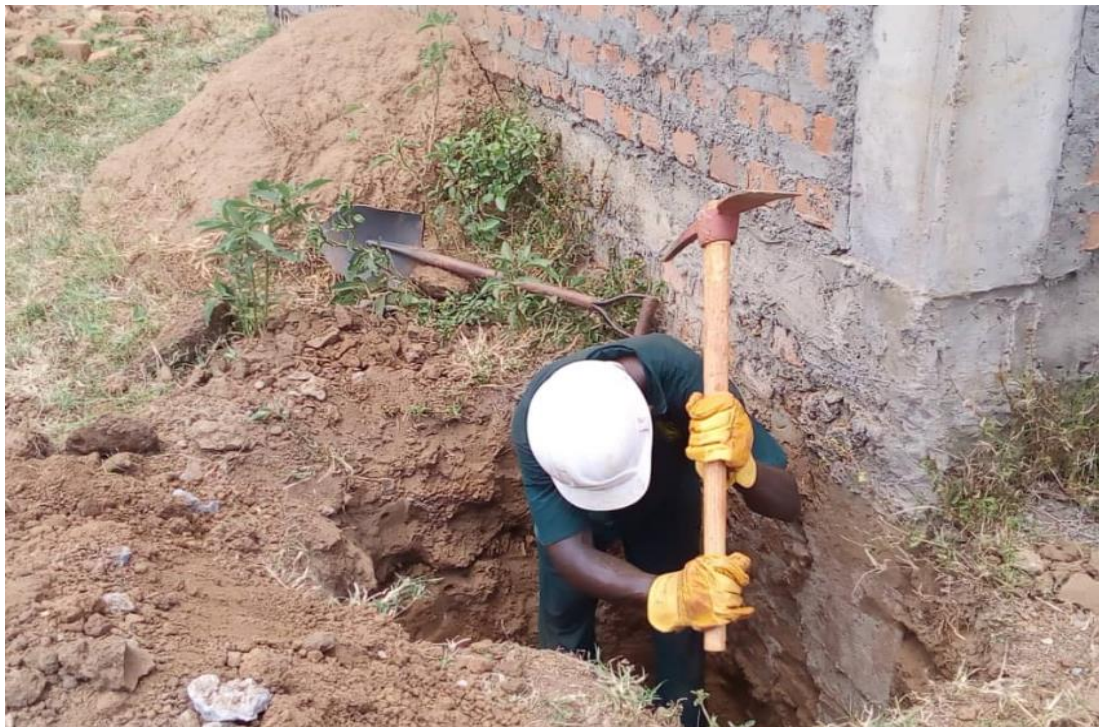
Photo plates 03: Manual excavation of test pit at one of the footing points

Two trial pits were sunk at approximate nominal distribution as presented on the site layout plan, each pit attaining a target depth of about 2.5 - 3.0m. Two of the test pits were located at foundation points. The test pitting operations were carried out manually with aid of hand tools such as hoes, spades and pick axes.

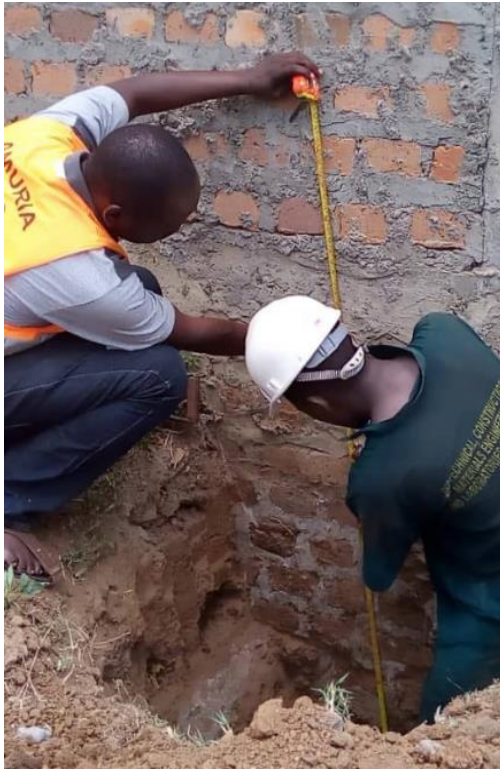
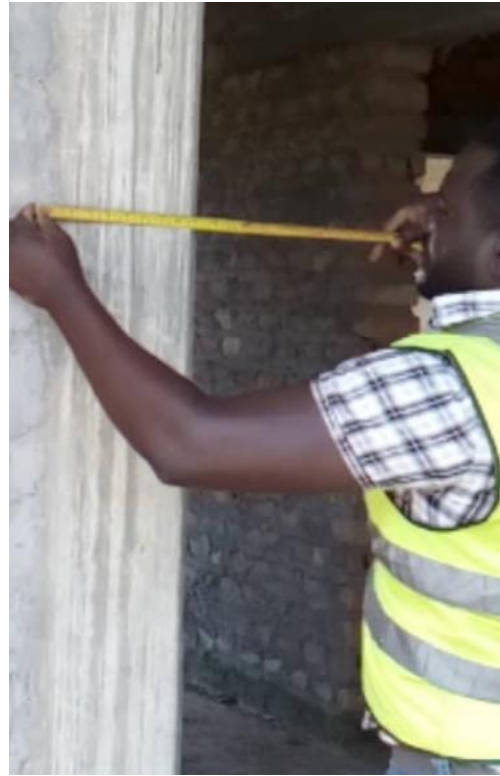
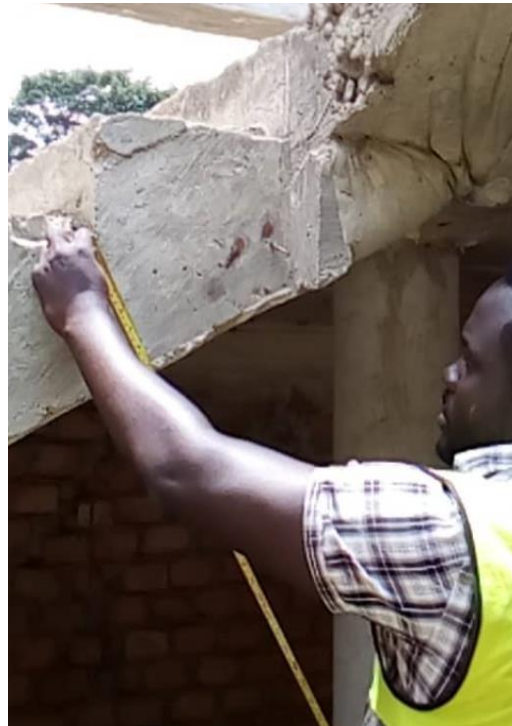
Photo plate 06: dimension measurement/check of structural members

Member	Dimension details	Remarks
COLUMNS	<p>Square columns Most of the columns were square columns with dimensions of 230 x 230mm and a floor to floor height of 3.05 – 3.1m</p> <p>Circular column The circular column was observed with 230mm circumference and also about 3050 – 3100mm floor to floor height.</p>	<p>Concrete was visually sound and the cover had good resistance to hacking.</p> <p>All aggregates used for concreting were observed to be of machine crushed type.</p>
BEAMS	All beams were found to have 500mm depth and 230mm wide.	
SLABS	The assessed max span slabs were observed to have 220 – 230mm thickness and a rib of width 130 – 145mm	
STAIR CASE	290 – 300mm treads, 150mm risers and a 150 – 160mm waist	
RAMP	The ramp was found to have a thickness of 200 – 250mm	
FOUNDATION	The foundation pads were of 1500 x 1500mm and a 290 - 300mm thickness

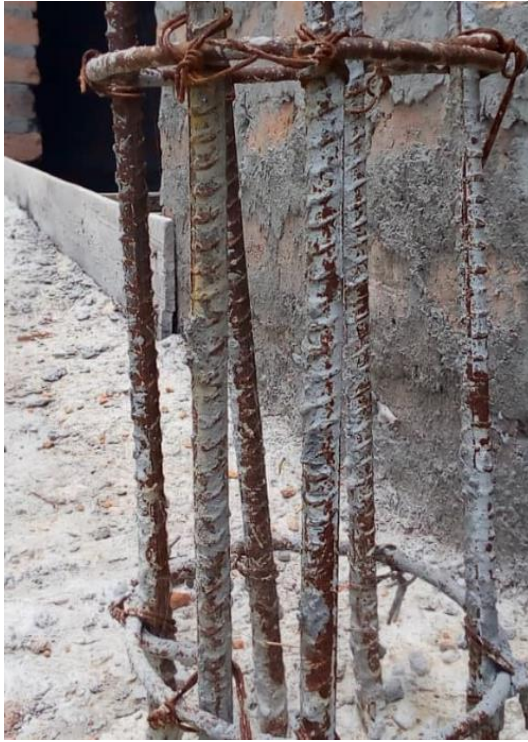
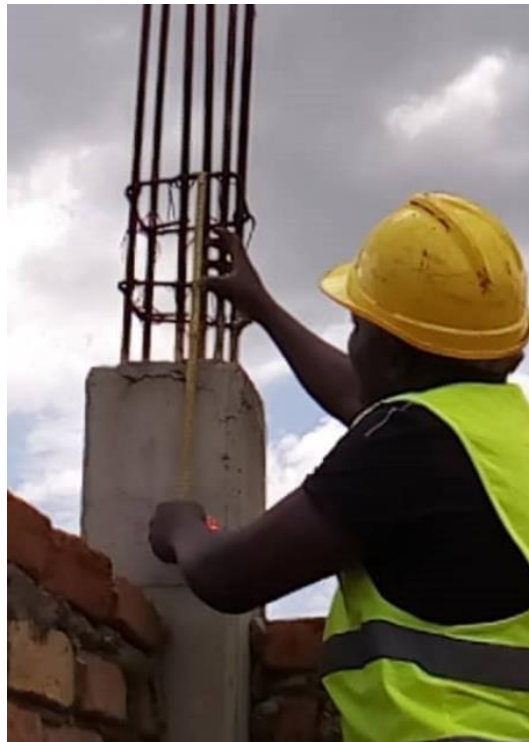
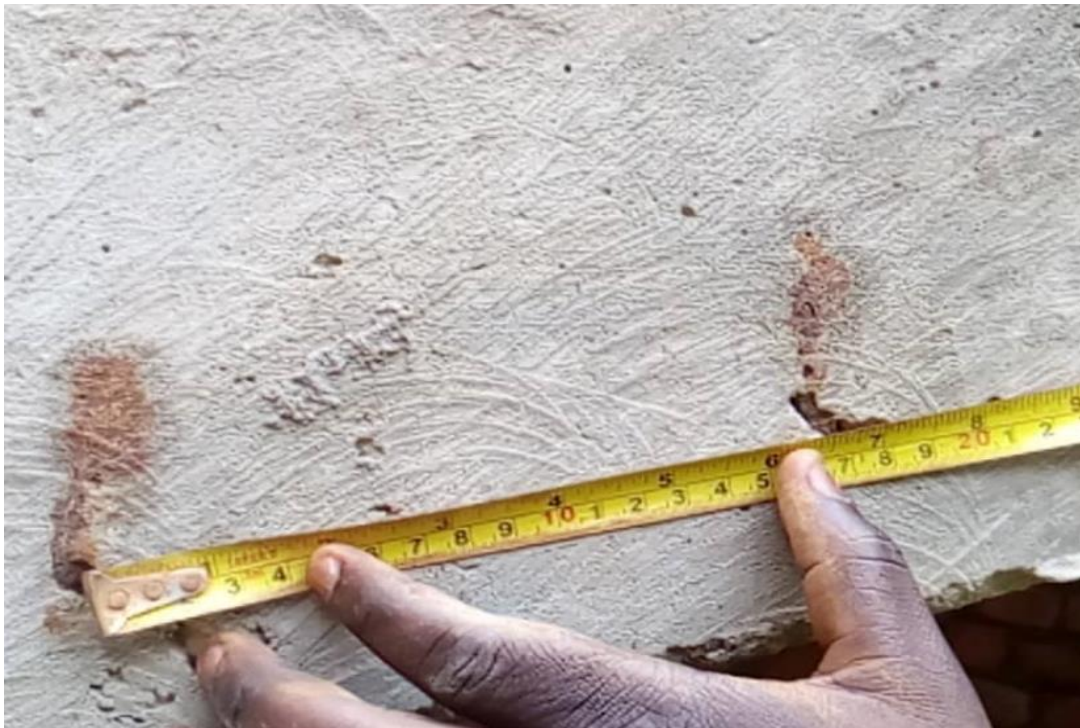
Photo plate 07: Reinforcement bar details being captured

Structural Member	As Built bar/reinforcement details	Remarks
COLUMNS	Square columns All columns were found with six, 16mm ribbed bars, wrapped in 8mm rings at a spacing of 170 - 175mm c/c	All structural analysis designs should be carried out with reference to this data.
	Circular columns (one) All circular columns were found with six 16mm ribbed bars, wrapped in 8mm rings at a spacing of also about 170 - 180mm c/c	
BEAMS	All the beams were found with three 16mm ribbed bars at the top and bottom, wrapped in 8mm rings at a spacing of about 180 - 190mm	
SLABS	The max span slabs were found to have two 12mm rebars in each rib	
STAIR CASE	The stairs had 12mm diameter twisted bars at a spacing of about 170mm in both directions, bottom at the bottom of the waist	
FOUNDATION	The foundation footings were found with 12mm diameter bars at a spacing of 150 - 160mm center to center, in both directions, bottom

The assessed concrete members were found to have sound reinforcement bars with no significant corrosive signs and reduction in girth/circumference. Please note that all the reinforcement bars were of twisted type.

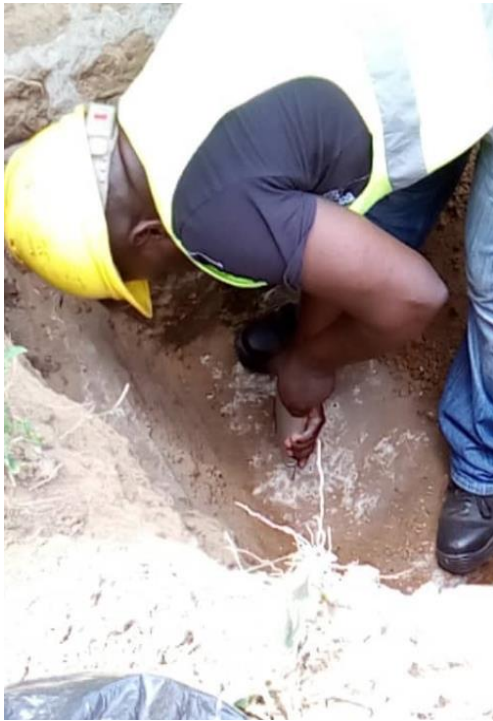
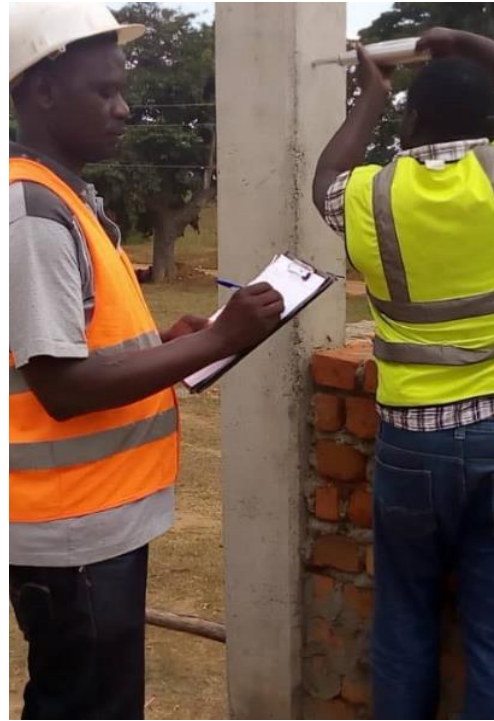
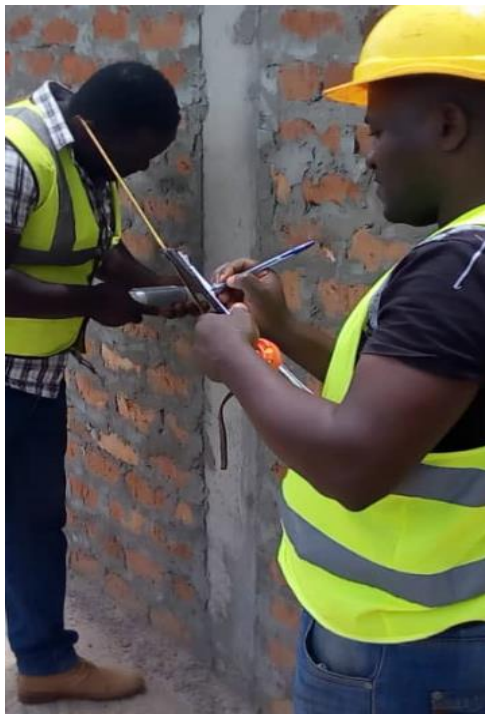
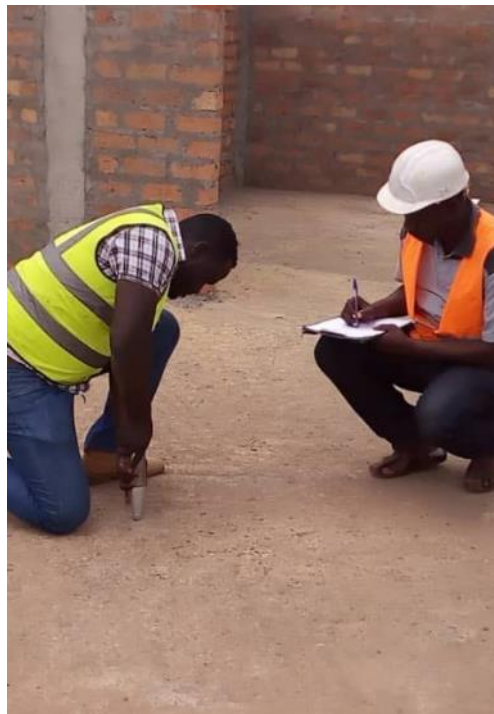
Photo plate 08: Rebound hammer tests for compressive strength on concrete members

The rebound hammer test revealed that the both the assessed buildings had a compressive strength that varies from **26 – 29Mpa**. It is therefore recommended that a maximum compressive strength of **26MPa** be used to assess the existing building for structural stability.

COMPRESSIVE STRENGTH TEST RESULTS FOR CONCRETE MEMBERS (SCHIMDT HAMMER TEST)				
Age of concrete: Past 28 days		Test conditions: Air dry		Date tested: 04/11/2018
STRUCTURAL MEMBER	STRUCTURAL LEVEL/POSITION	REFERENCE GRID MARK	ANGLE OF REBOUND SHOT, (DEGREES)	AVERAGE COMPRESSIVE STRENGTH (MPA)
BEAMS	FIRST FLOOR	Along grid B	+90	27
		Along grid A	+90	27
		Along grid 2	0	26
		Along grid 8	0	28
		Along grid 10	0	28
		Along grid 11	+90	27
		Along grid F	+90	28
STAIR CASE A	GROUND FLOOR	STAIR CASE SLAB	0	28
STAIR CASE B			+45	28
			0	27
FOUNDATION	5,D	PLINTH COLMN	0	28
		FOOTING	-90	28
COLUMNS	GROUNG FLOOR	2,A	0	29
		5,D	0	28
		1,D	0	27
		2,G	0	27
		10,G	0	28
		2,F	0	28
	FIRST FLOOR	5,A	0	28
		9,F	0	29
		11,B	0	27
		4,B	0	28
SLABS	FIRST FLOOR SLAB	Randomly selected point in slab panels	-90	26
			-90	26
			-90	27
			-90	27
			-90	26
			-90	26
	GROUND FLOOR SLAB		-90	26
			-90	27
			-90	28
			-90	27

Based on the rebound hammer test results, compressive strength for concrete members was found varying from 26 – 29MPa, as presented in the findings. Should the building be found unstable under existing moments and stresses, additional bracing should be considered to ensure stability or consider it unstable. It is further recommended that a maximum design compressive strength of **26MPa** (average) be used for concrete design and assessment of the buildings.

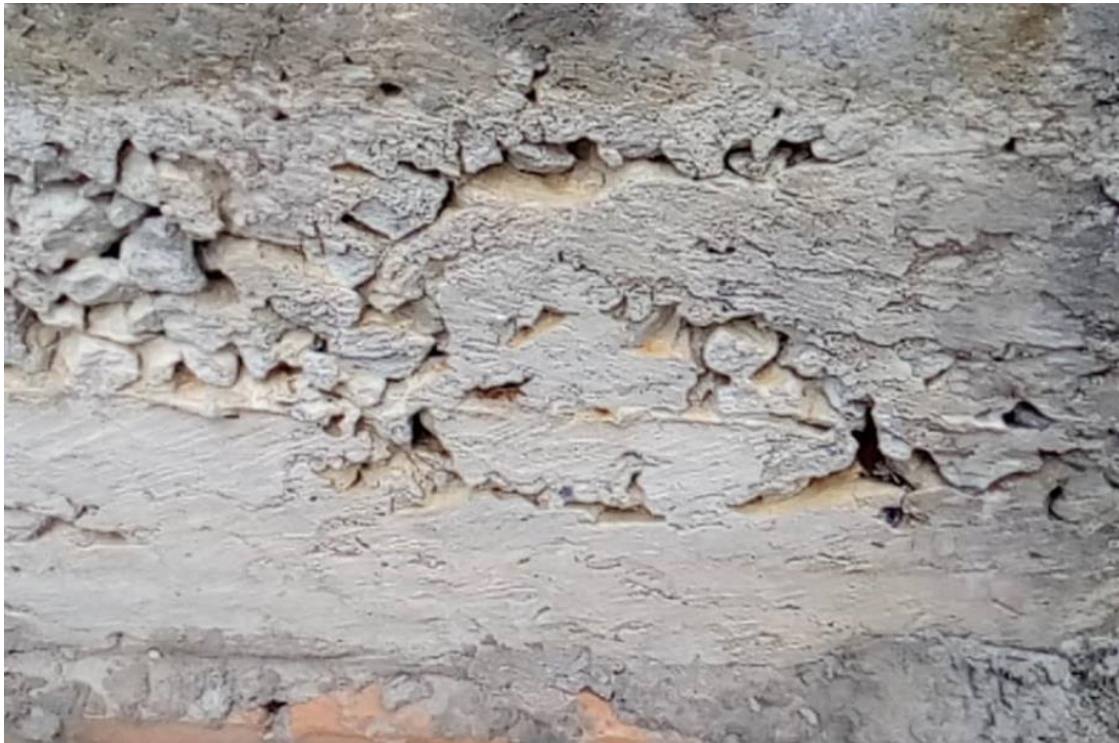
Photo plate 10: Honey combings observed in some area.

Visual inspection was also done to check for any concrete surface defects. Some honey combed surfaces were observed and sufficient concrete cover was observed to be provided to the reinforcement. Please note that all main bars in the as-built structure were of **Ribbed type (approx. 500 MPa tensile strength)**

It should be noted that the building was found in an incomplete state and pending addition of more floor levels by the client at the time of investigation. Some concrete defects such as efflorescence, shrinkage cracking, honey combings and rebar exposure were observed and require immediate remediation as explained.

S/No.	Defects	Remarks / Proposed Remedies
1	Concrete honey combs were observed.	Immediate grouting to stop rebar exposure, which may lead to corrosion and oxidation
2	Some cases of exposed rebar were observed, due to insufficient cover and honey combed surfaces	
4	Small walling cracks of non-structural effect were observed in some areas	Mortar infill in cracks, application of mesh along cracks, re-application of plaster.
5	Ceiling All ceiling/slab soffit were observed to be structurally sound though with slight efflorescence.	n/a
6	Concrete slab floor Few shrinkage cracks were observed especially on the ground floor slab. It should be noted that though shrinkage cracks are of no structural effect in ground floor slabs, they should be remedied to facilitates proper floor finishes.
